Neighborhood Stabilization Program 2 (NSP2)

Invitation for Bids – General Contractor

2201 Joliet St., Flint, MI 48504

BID NUMBER: LB 11-032

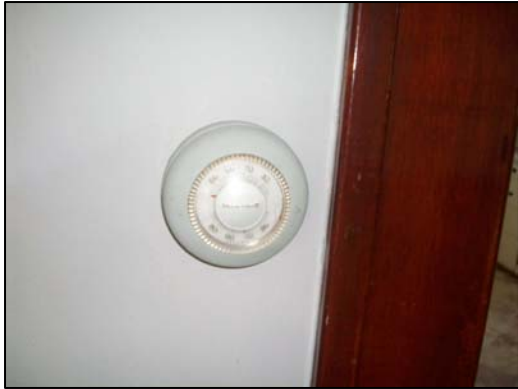
Mercury Thermostat
Dining room

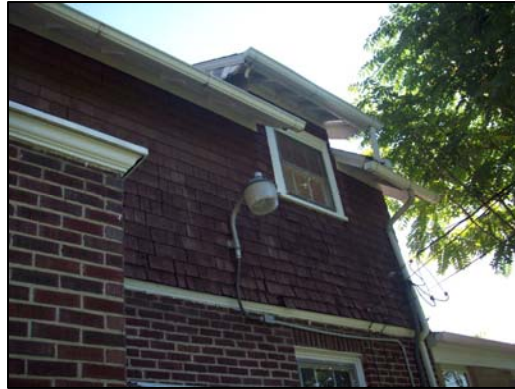
Mercury Light
Back of House

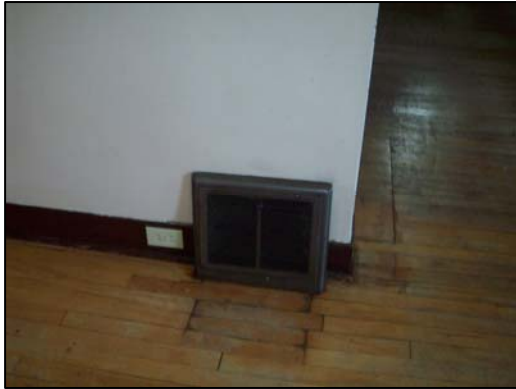
Example of Duct Wrap - Friable Register Boots/Runs Throughout

Bolded and Shaded materials contain asbestos and Global recommends the materials be removed prior to renovation/demolition activities

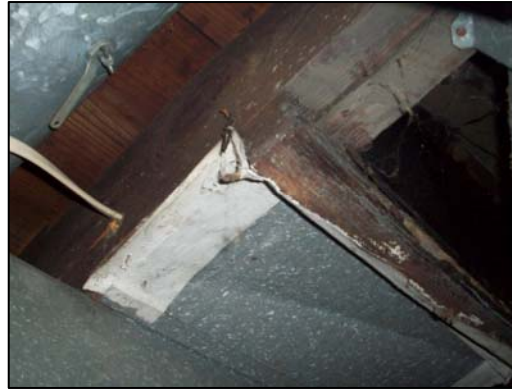
Example of Duct Wrap Tape - Friable Basement
