Neighborhood Stabilization Program 2 (NSP2)

Invitation for Bids – General Contractor

1659 N. Grand Traverse St., Flint, MI 48503

BID NUMBER: LB 11-026

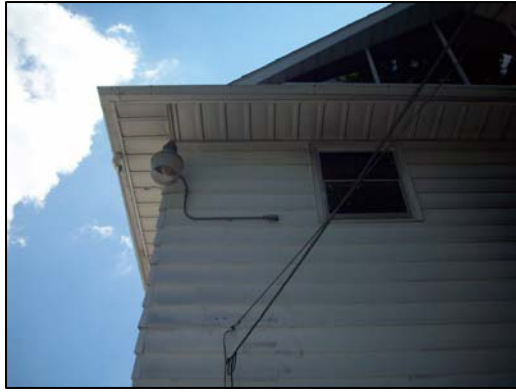
Mercury Light
Back of House

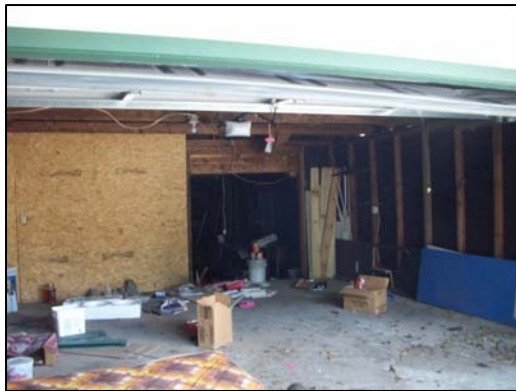
Paint and Fire & Ice
Garage

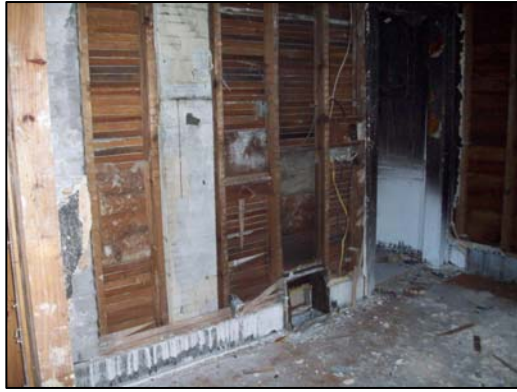
Duct Wrap
Register Boots/Runs Throughout

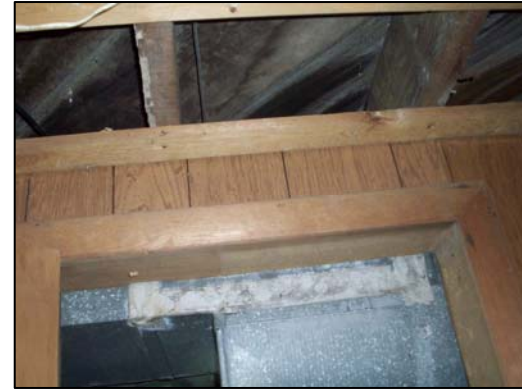
Duct Wrap – 2" Tape
Basement

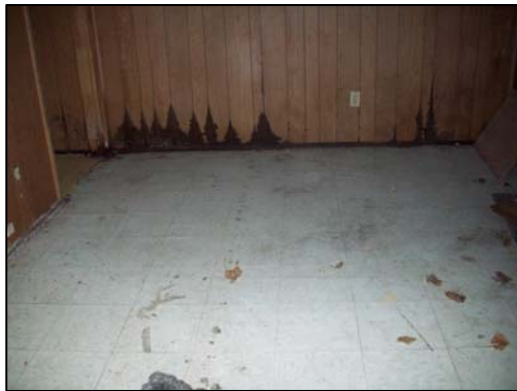
12" Floor Tile with Streaks
Basement
