Genesee County Land Bank Authority

Neighborhood Stabilization Program 2 (NSP2)

Invitation for Bids – Exterior General Contractor

924 Eddy St., Flint, MI 48503

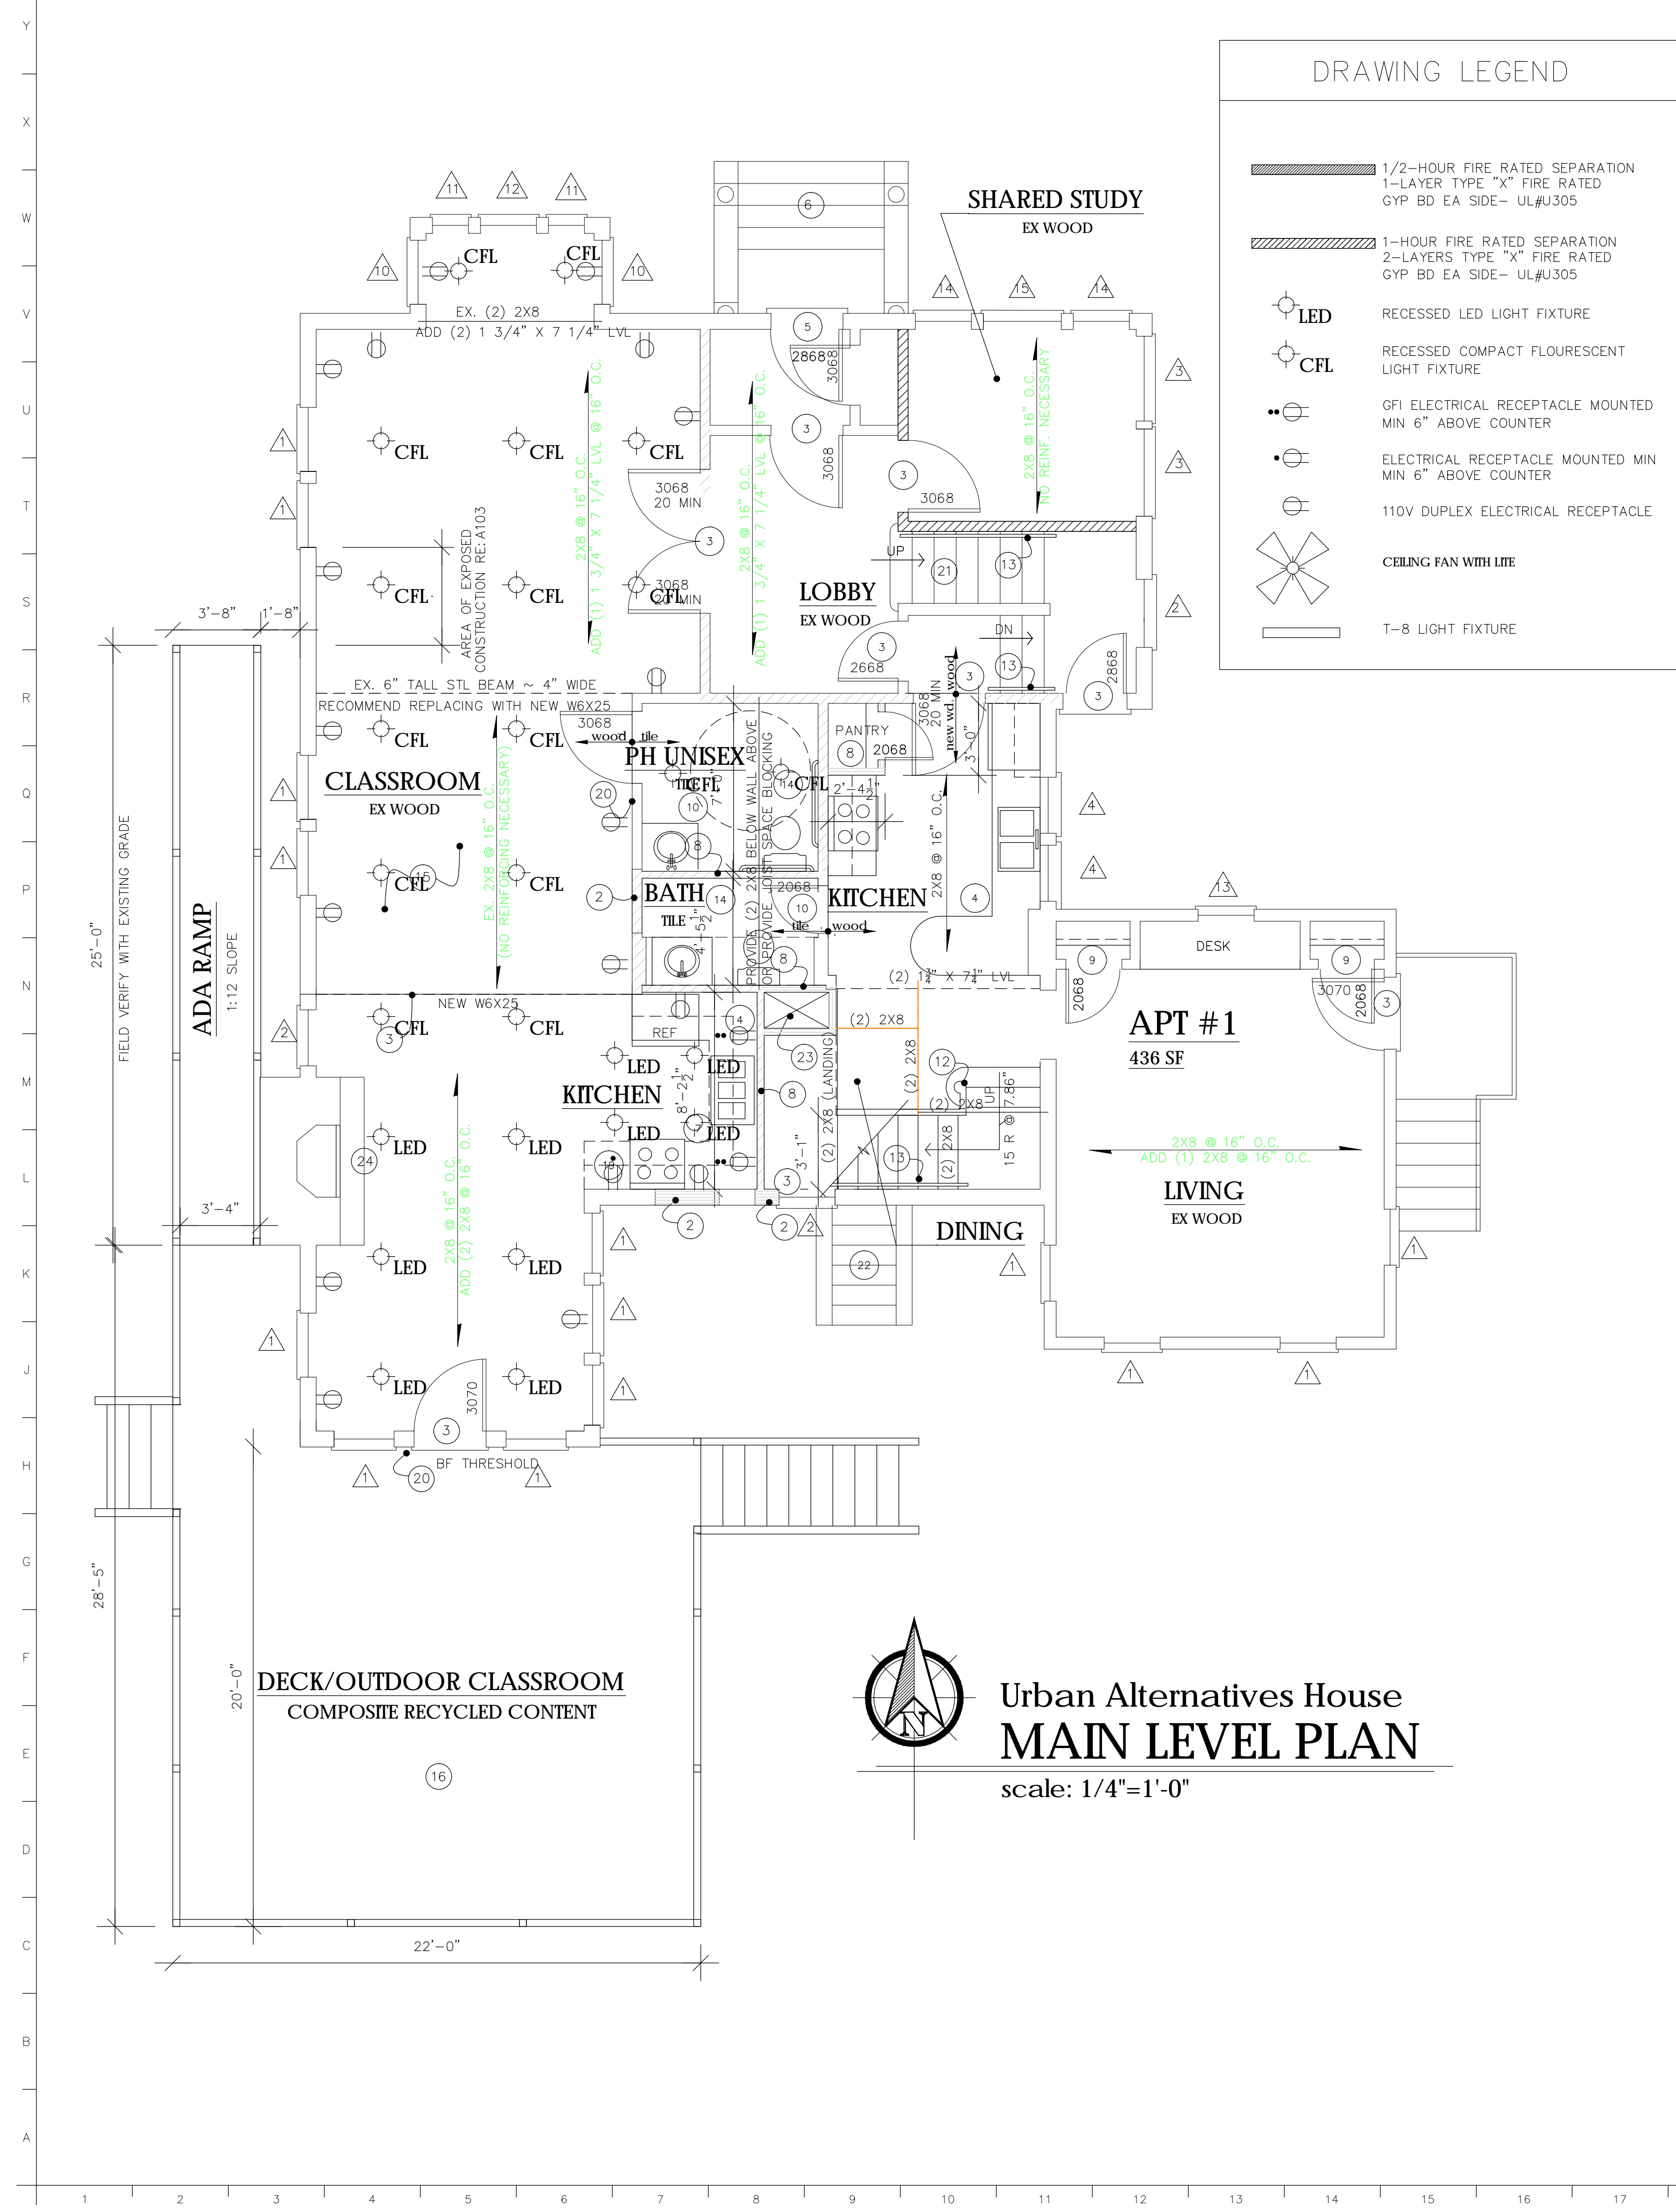
Urban Alternatives House
MAIN LEVEL PLAN
scale: 1/4"=1'-0"

1/2-HOUR FIRE RATED SEPARATION 1-LAYER TYPE "X" FIRE RATED GYP BD EA SIDE - UL#U305
	1-HOUR FIRE RATED SEPARATION 2-LAYERS TYPE "X" FIRE RATED GYP BD EA SIDE - UL#U305
	LED RECESSED LED LIGHT FIXTURE
	CFL RECESSED COMPACT FLOURESCENT LIGHT FIXTURE
	GFI ELECTRICAL RECEPTACLE MOUNTED MIN 6" ABOVE COUNTER
	ELECTRICAL RECEPTACLE MOUNTED MIN MIN 6" ABOVE COUNTER
	110V DUPLEX ELECTRICAL RECEPTACLE
	CEILING FAN WITH LIGHT
	T-8 LIGHT FIXTURE

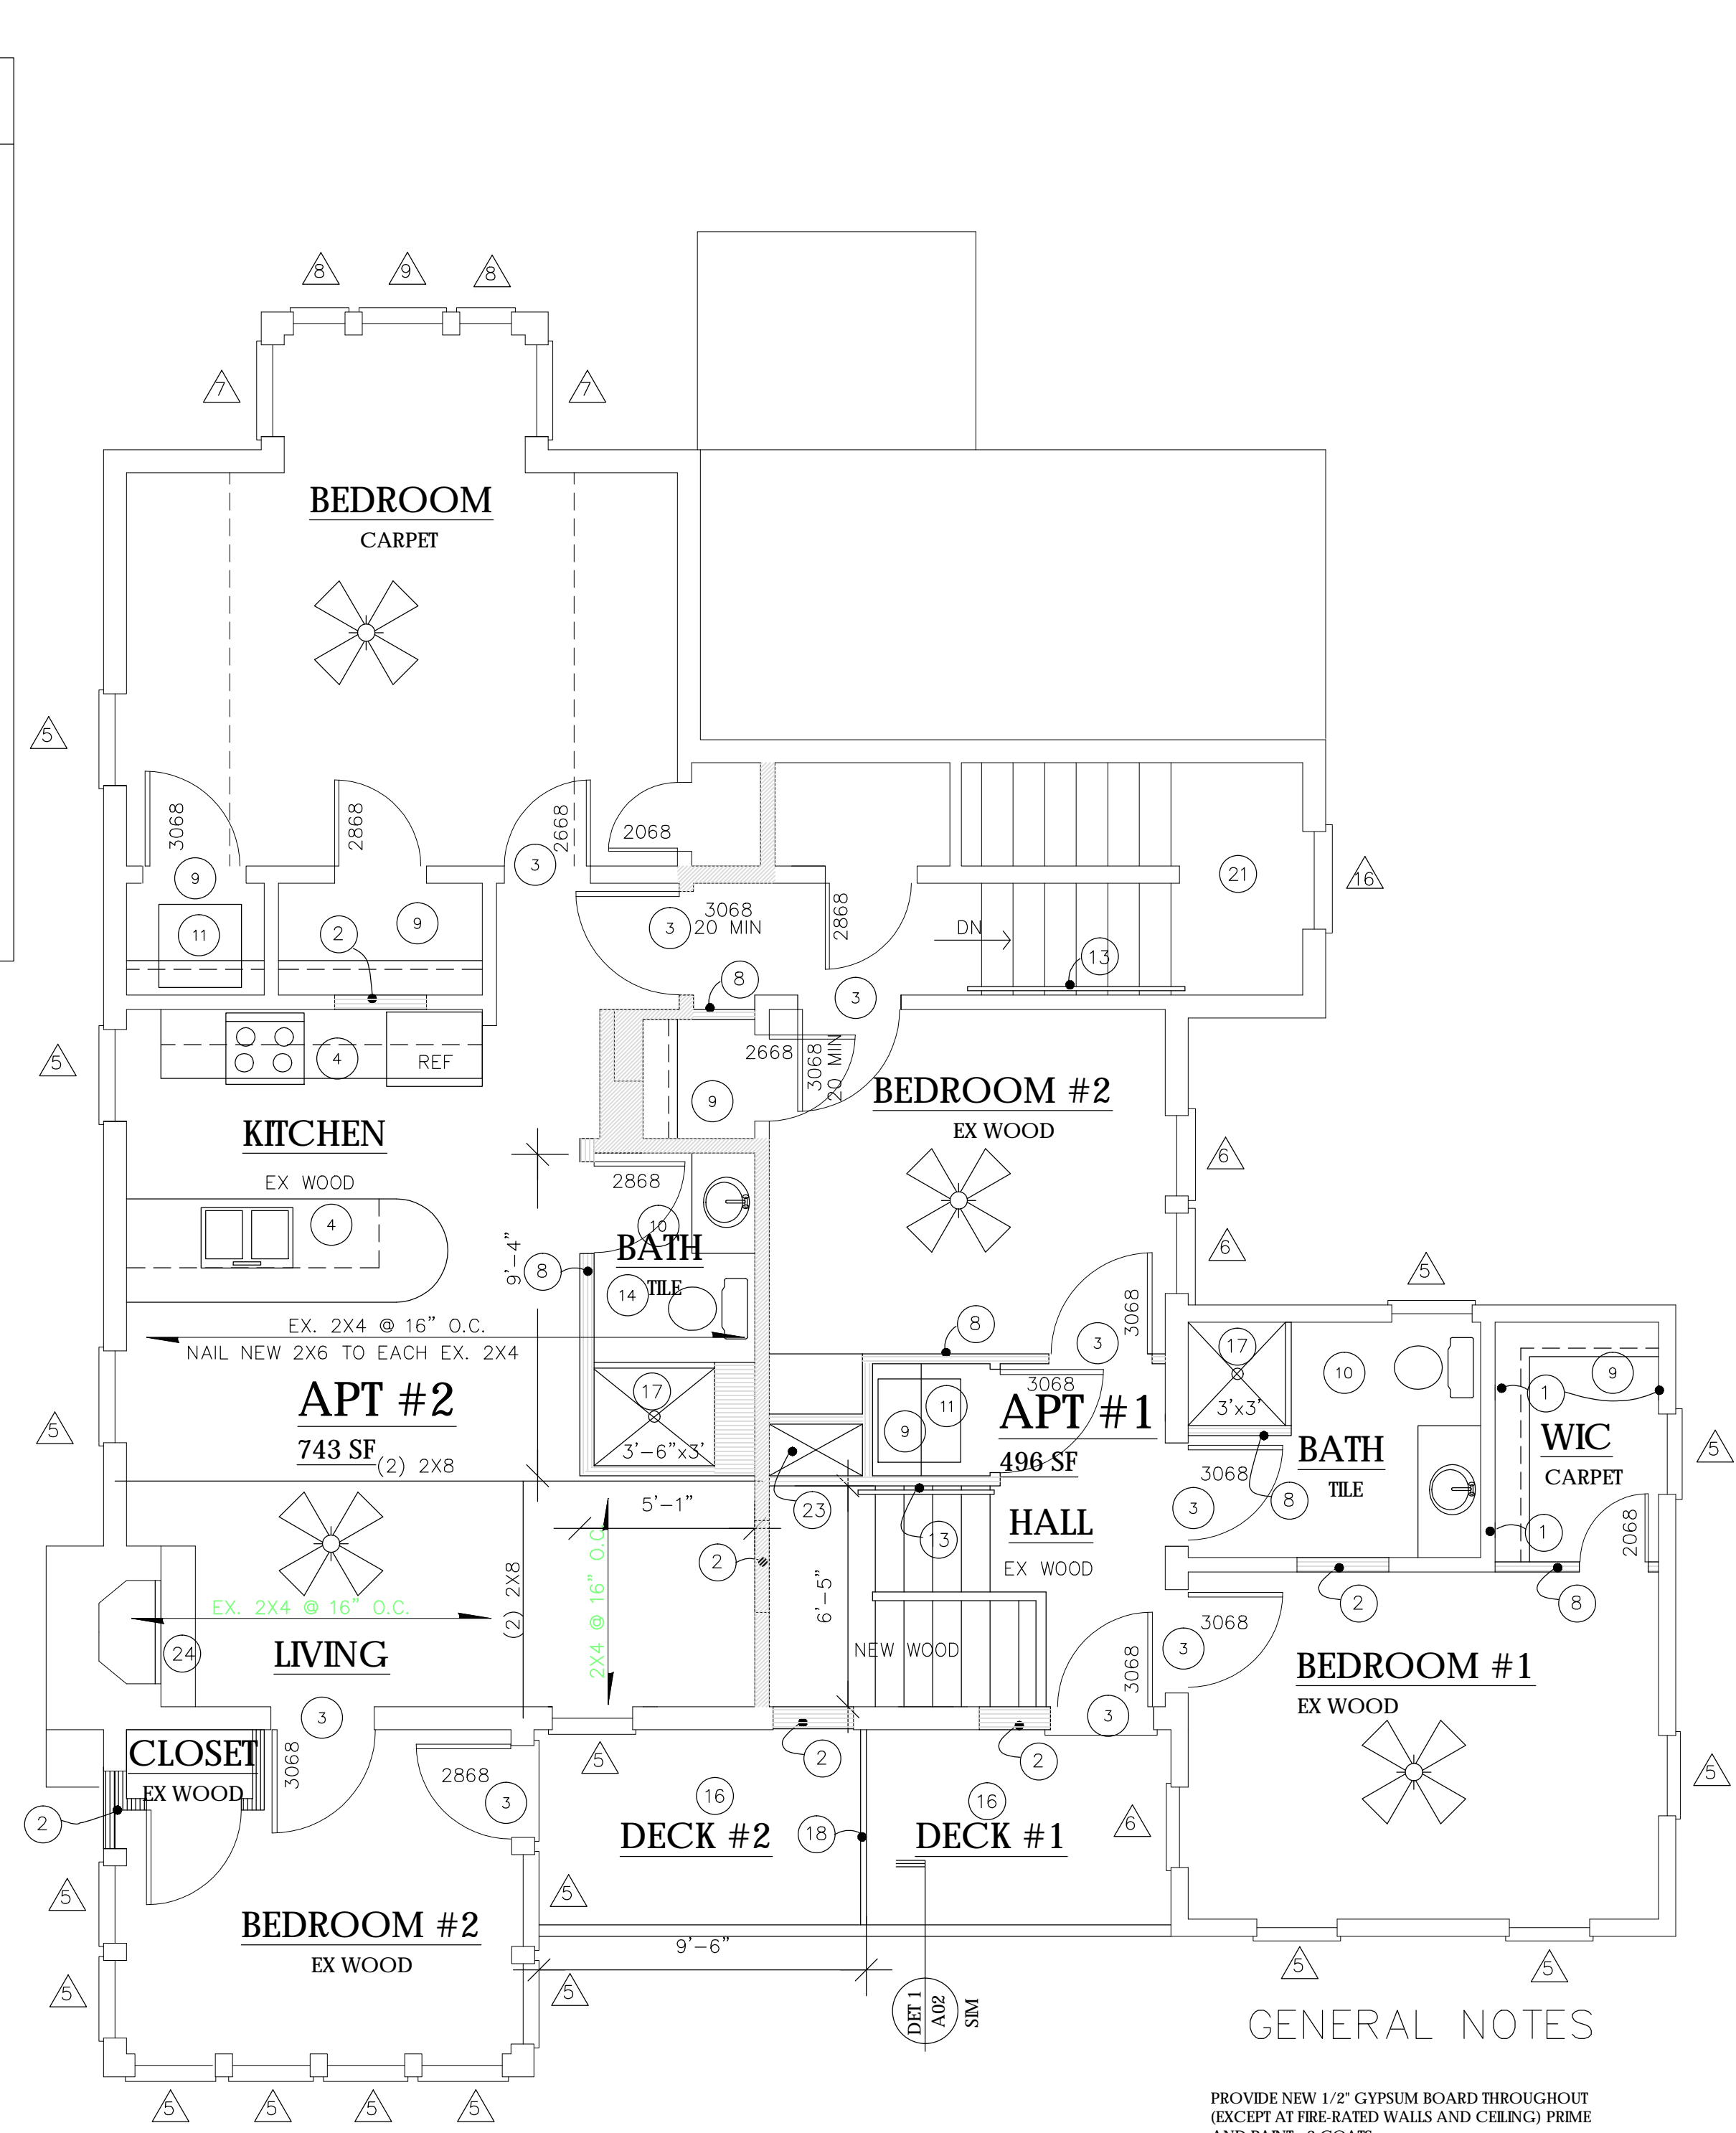
Urban Alternatives House
UPPER LEVEL PLAN
scale: 1/4"=1'-0"

3. PROVIDE NEW (2) 2x8 HEADER
4. NEW CABINERY BY MANUFACTURER RE SPEC
5. NEW WOOD ROUND TOP ENTRANCE DOOR & FRAME
6. PROVIDE NEW WOOD BASE UNDER EXISTING COLUMNS. PROVIDE NEW BRICK PORCH (MATCH CHIMNEY) RE-USE LIMESTONE CAPS; REPLACE 2 LIMESTONE TREADS AND RSERS

7. NEW 3 COMPARTMENT STAINLESS STEEL SINK RE-SPEC
8. NEW 3/2" WOOD STUD WALL
9. COAT ROD & SHELF
10. VINYL TILE W/ WOOD BASE
11. NEW STACKABLE WASHER/DRYER COMBO RE-SPEC

17. FIBERGLASS SHOWER INSERT RE-SPEC
18. WOOD PRIVACY SCREEN
19. KITCHEN CABINETS RE SPEC
20. PH SIGN DETAIL THIS SHEET
21. PATCH / REPAIR EXISTING WOOD STAIR AS REQUIRED

22. PATCH / REPAIR EXISTING CONC STEPS AS REQUIRED
23. VERTICAL MECHANICAL CHASE - 1 HR RATED
24. PROVIDE AIRTIGHT FIREPLACE ENCLOSURE RE SPEC

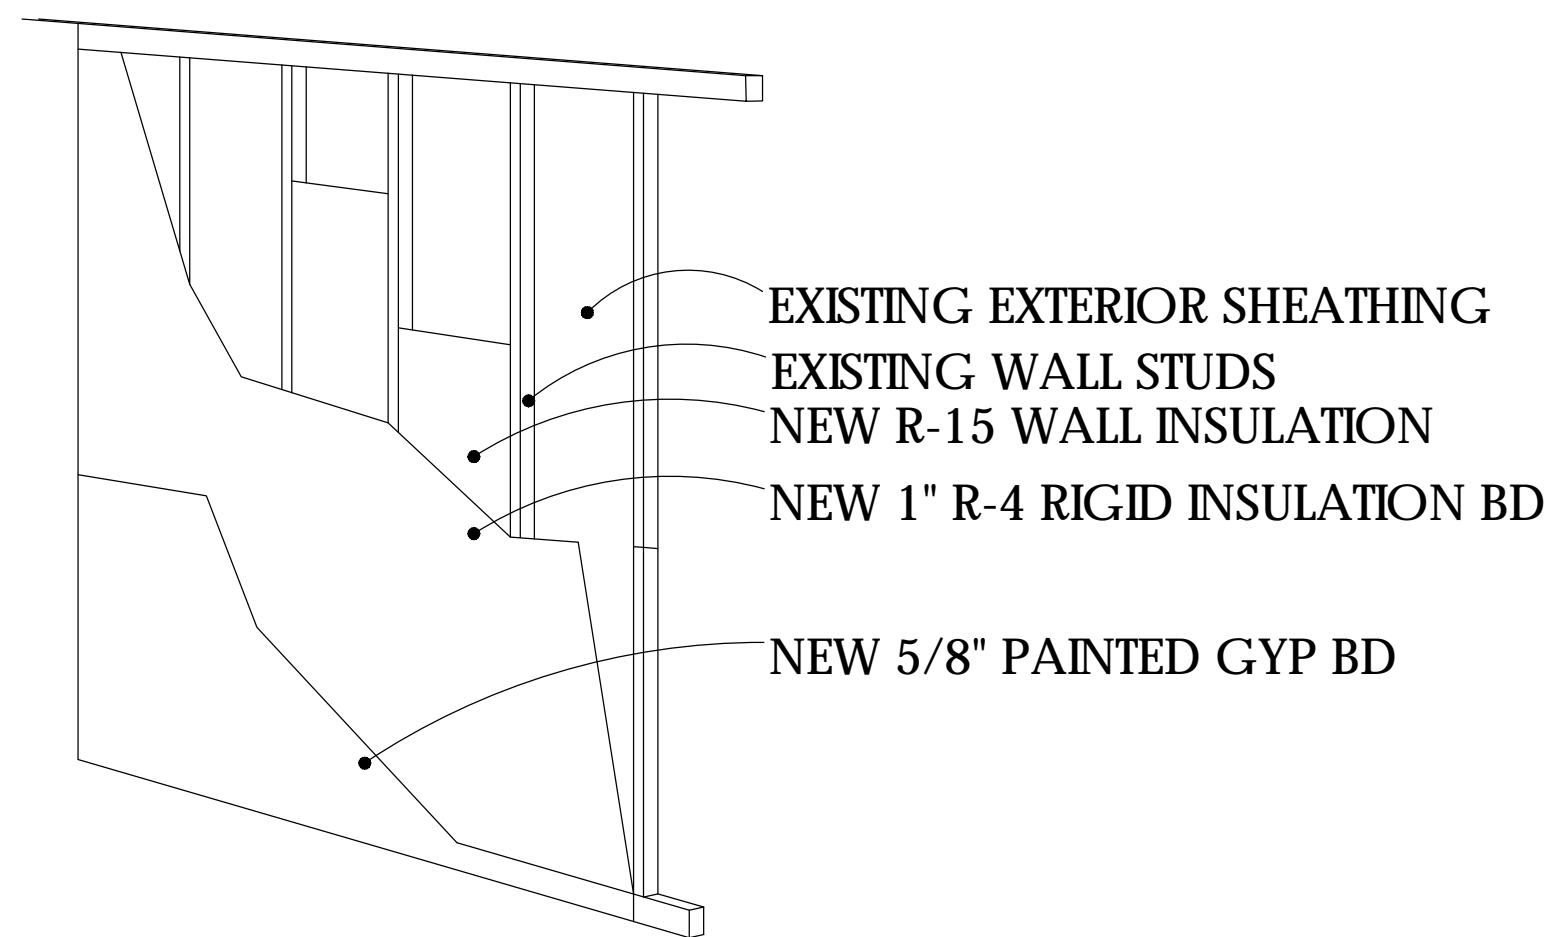
Urban Alternatives House INTERIOR WALL ELEVATION

AT CLASSROOM SPACE- LEAVE 3'X7' PORTION OF WALL EXPOSED UNDER 1/4" TEMPERED GLASS TO SHOW WALL INSUL & CONSTRUCTION AS BELOW

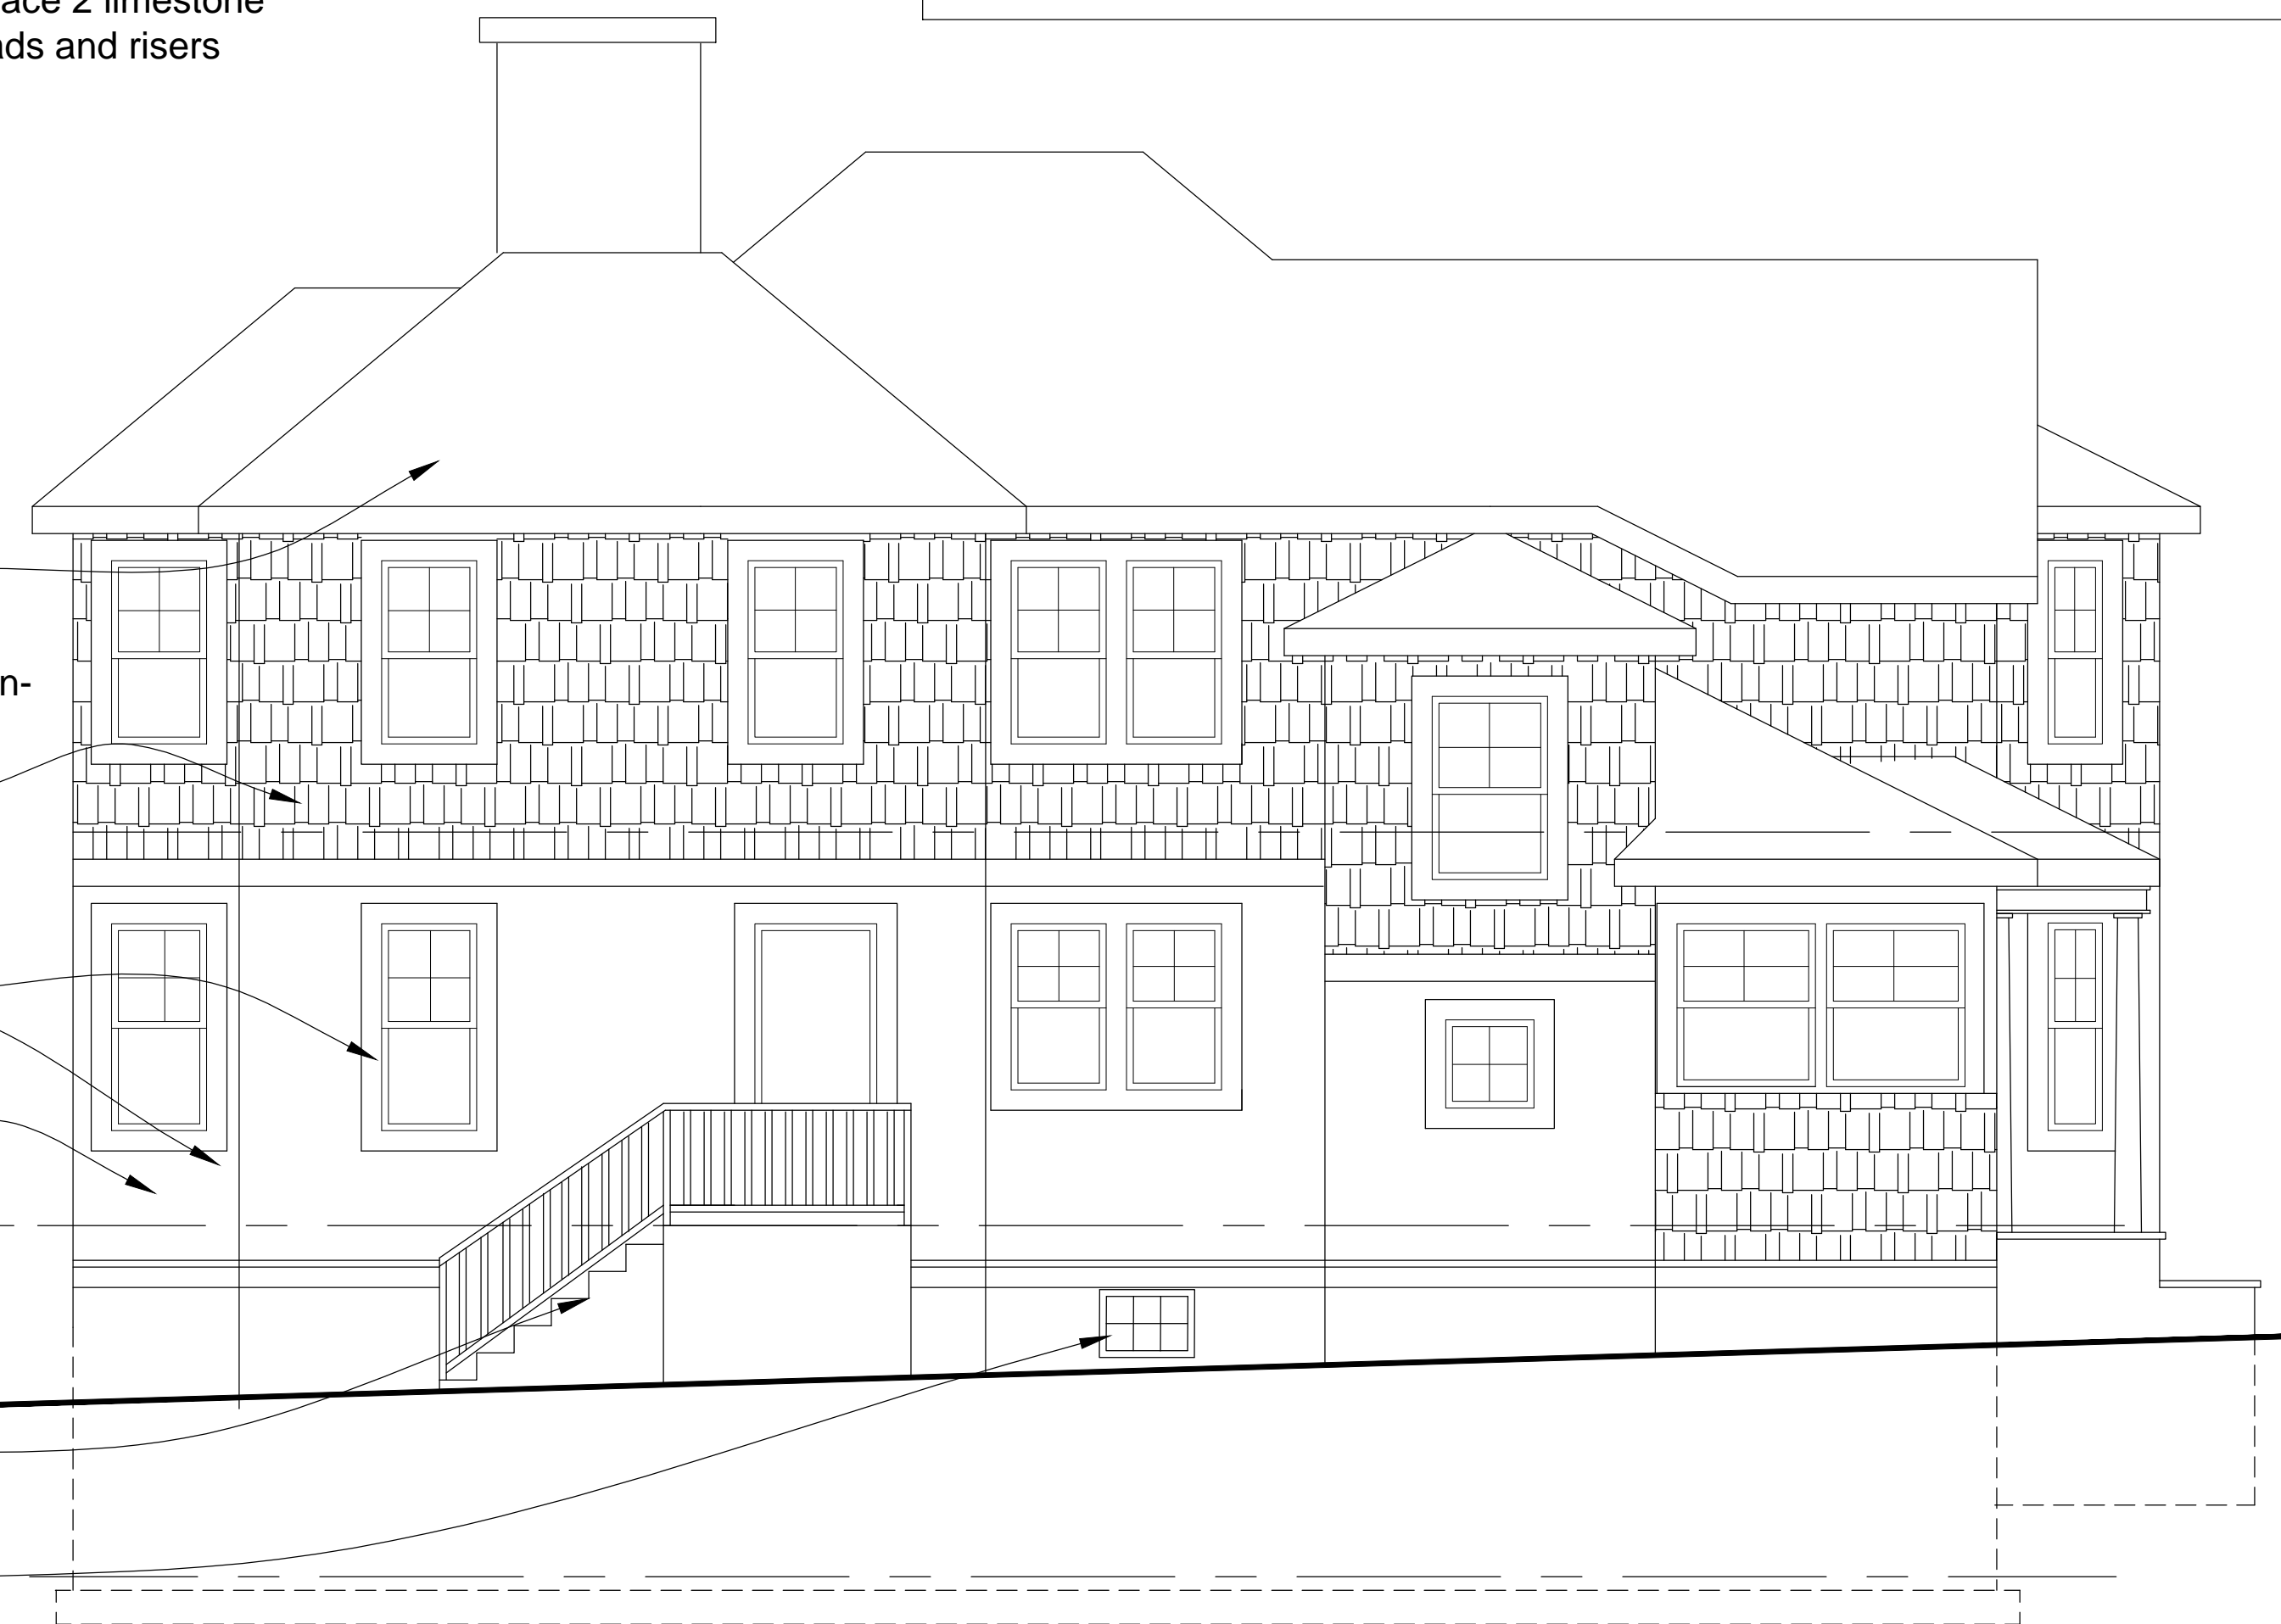
Urban Alternatives House EAST ELEVATION

existing shake siding to remain- strip and repaint- repair damaged shakes as needed provide new flashing at all corners

existing conc stair and railing to remain

new glass block at basement windows, typ

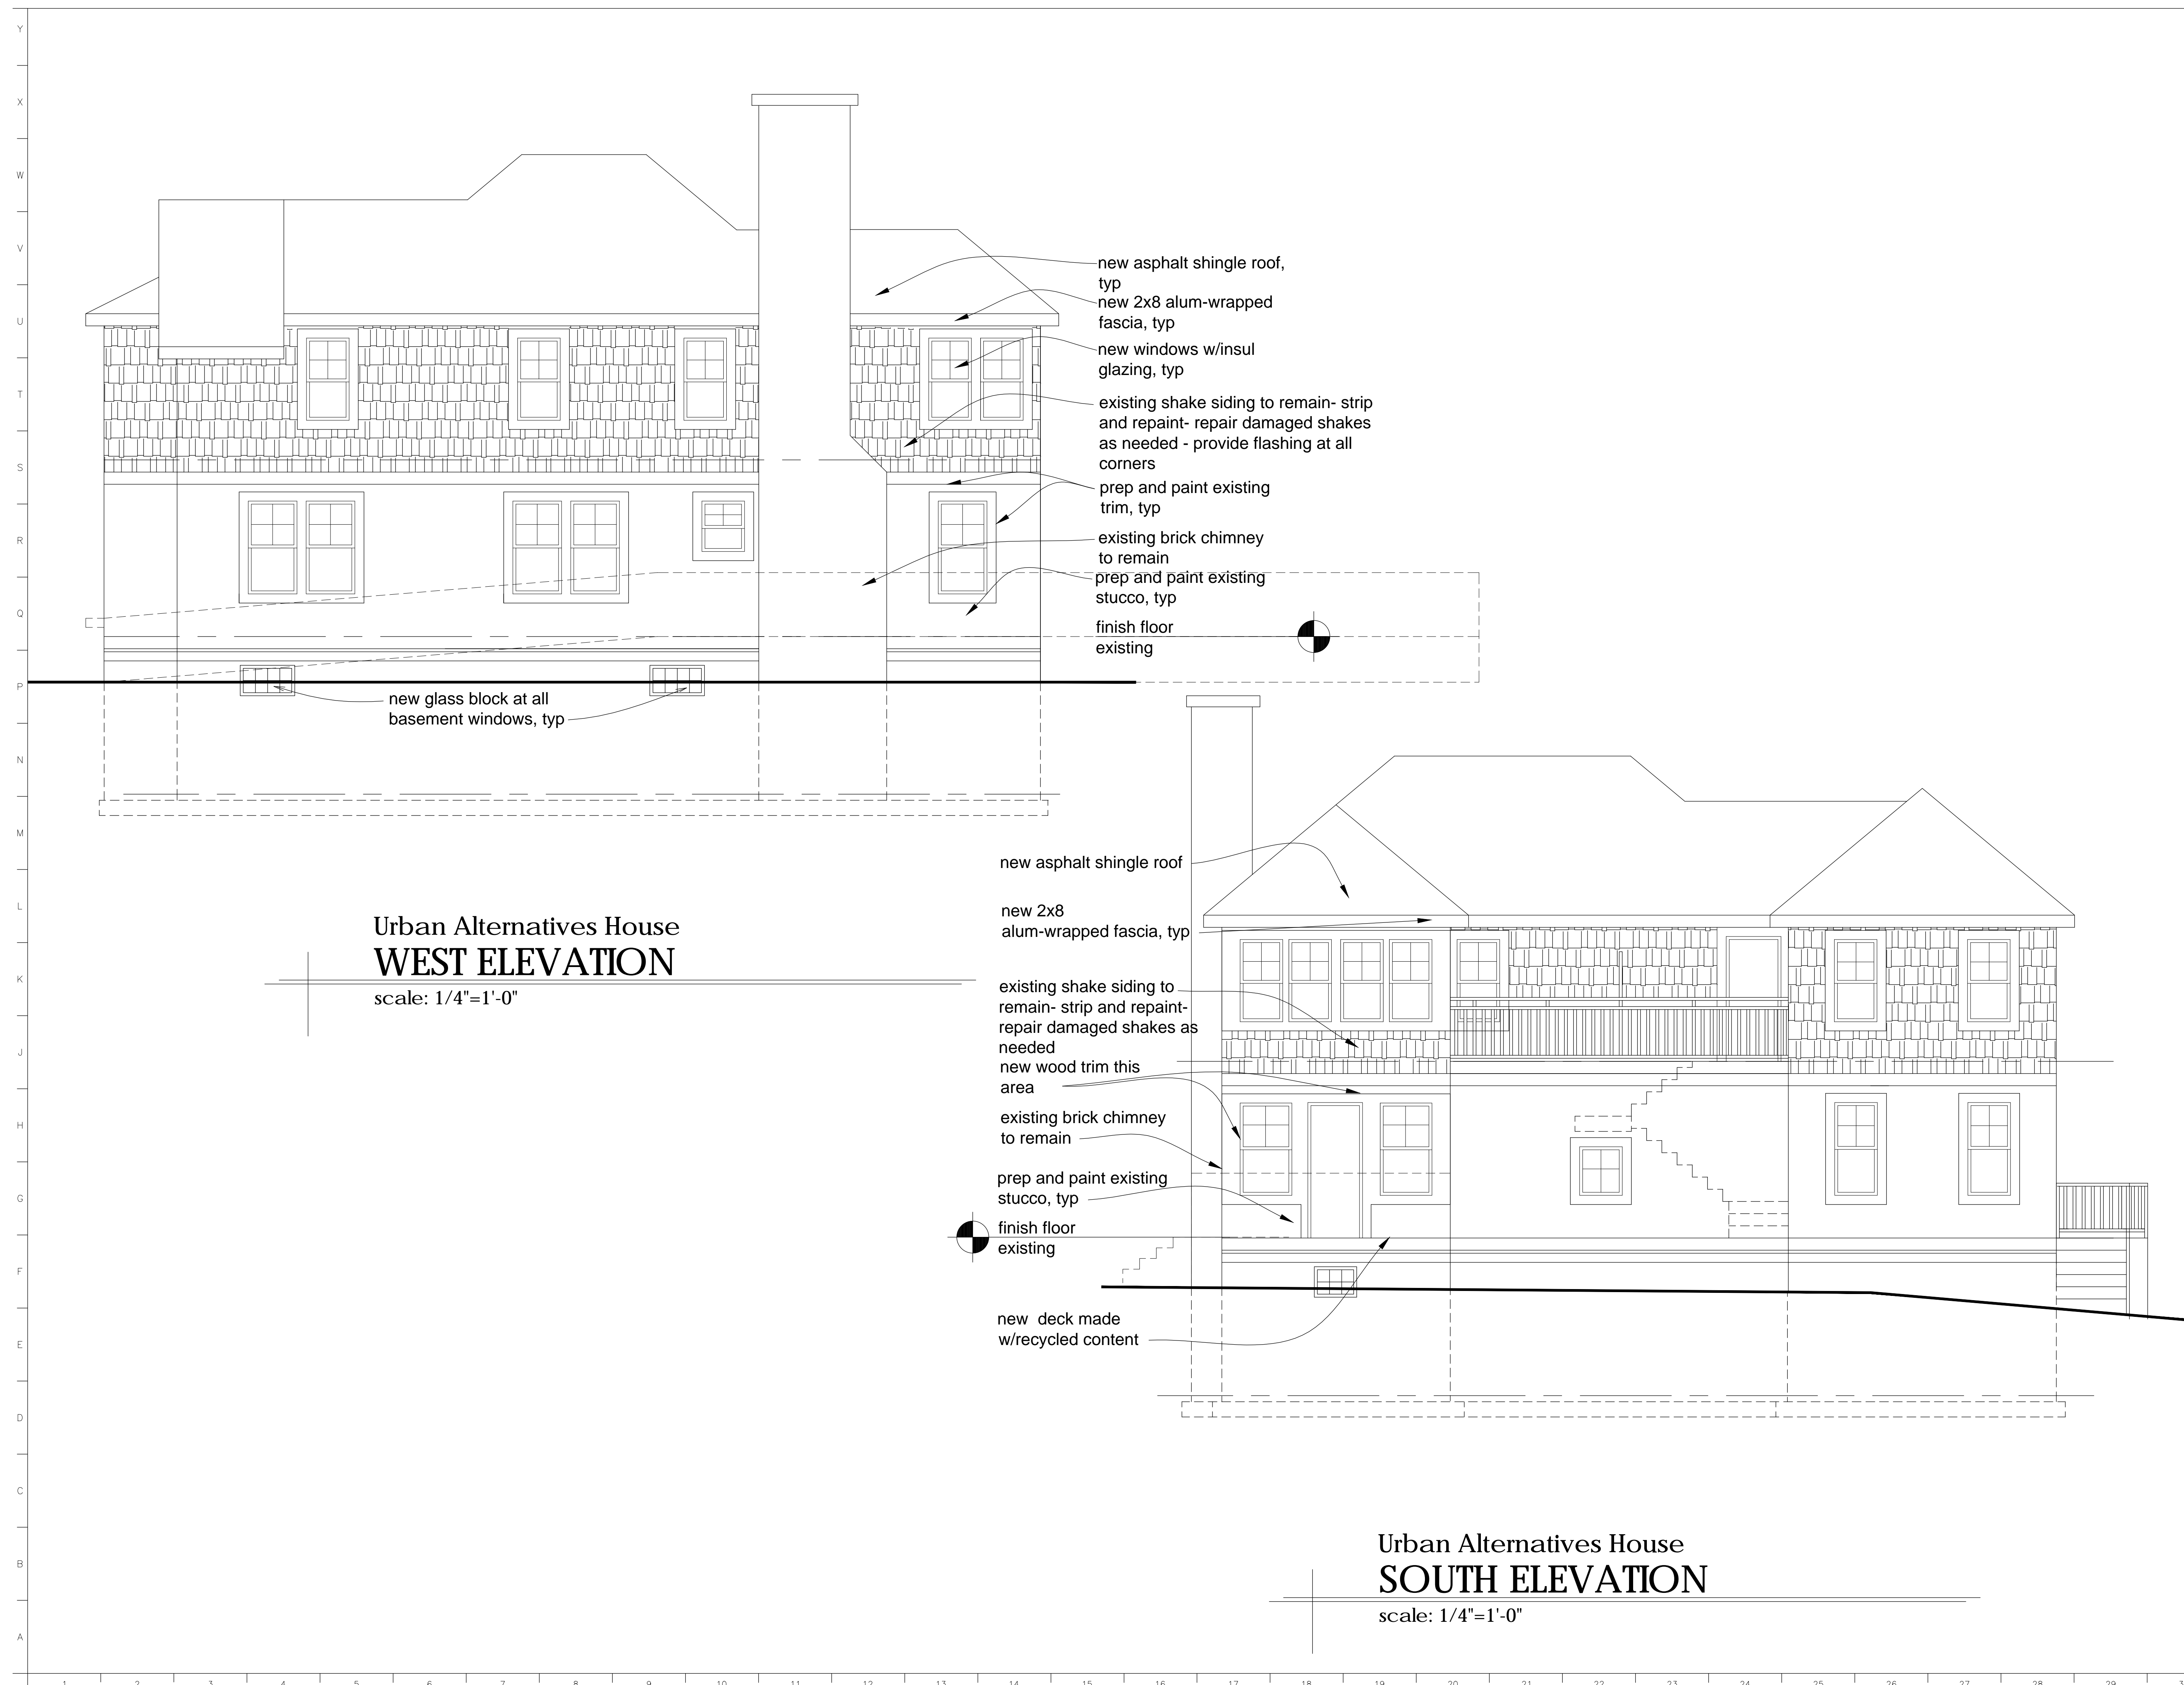
Urban Alternatives House
WEST ELEVATION

existing shake siding to remain- strip and repaint- repair damaged shakes as needed
new wood trim this area

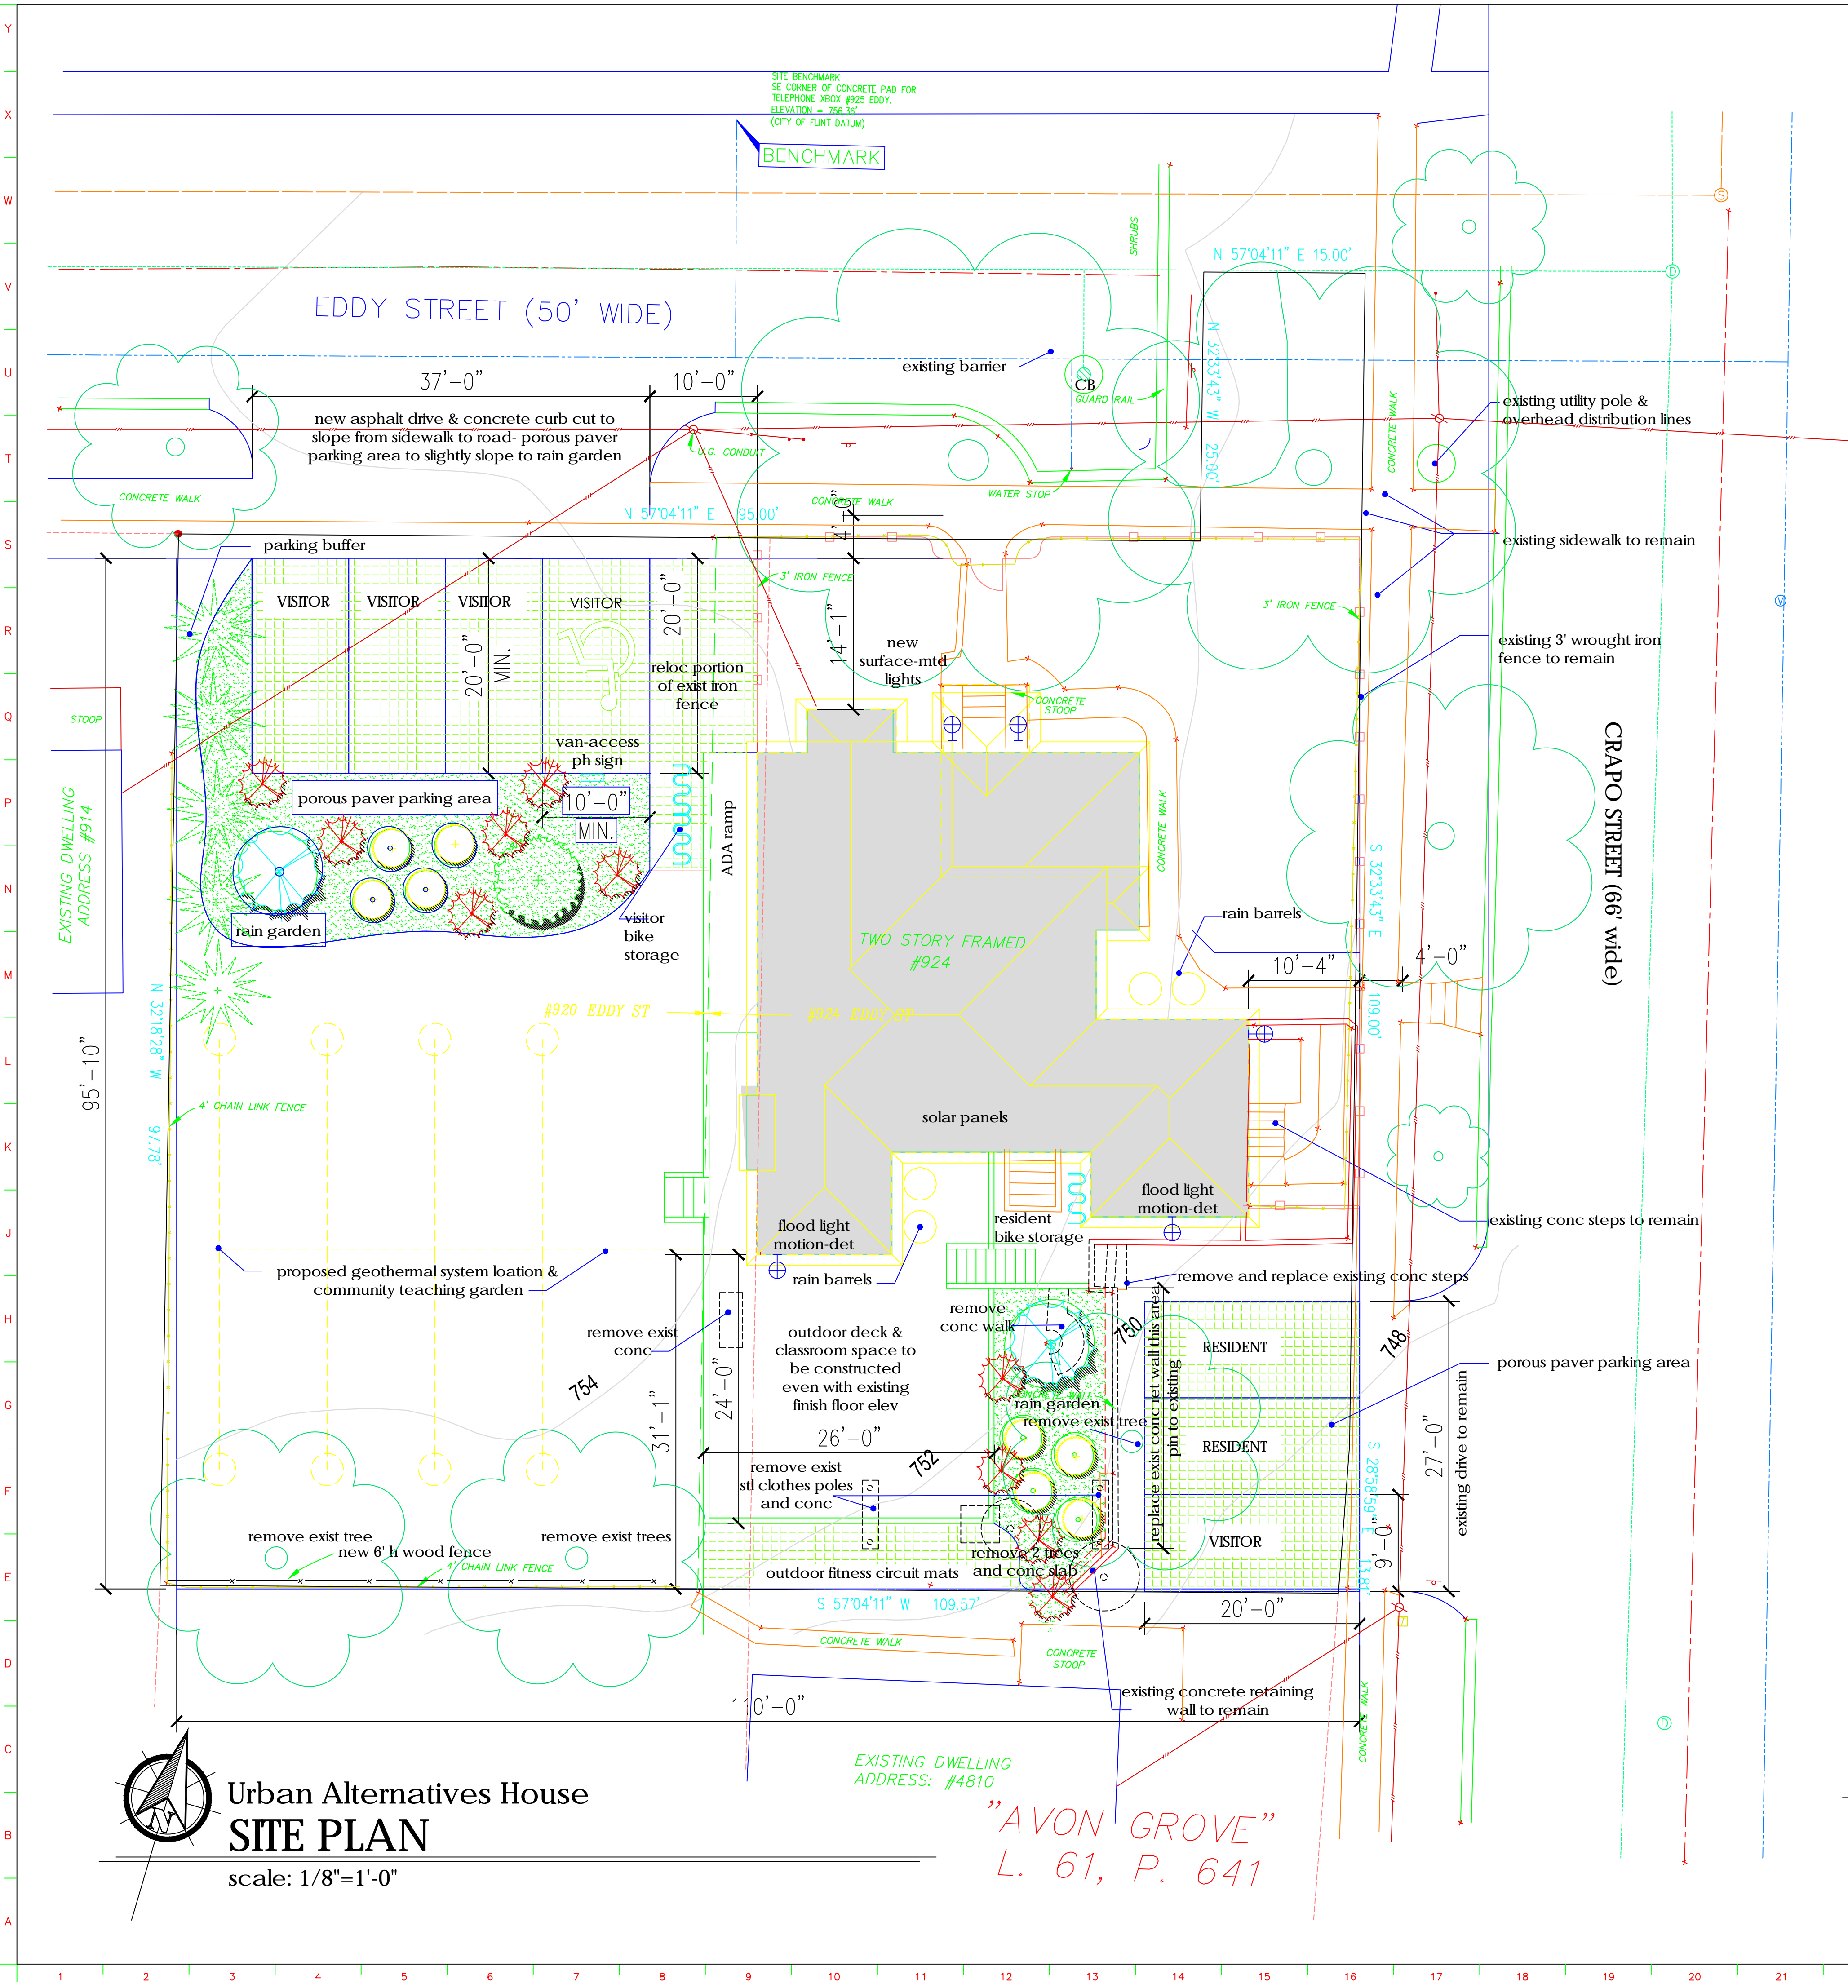
Urban Alternatives House
SITE PLAN
 scale: 1/8"=1'-0"

- porous paver
- rain garden
- existing wrought iron fence
- existing topography line
- Techny Arborvitae
- Dogwood or Serviceberry
- Bayberry
- Chokecherry or Elderberry Shrubs
- Daylilies or Black Eyed Susans or Blue Flag Iris
- Exterior Light Fixture
- Existing Catch Basin to remain

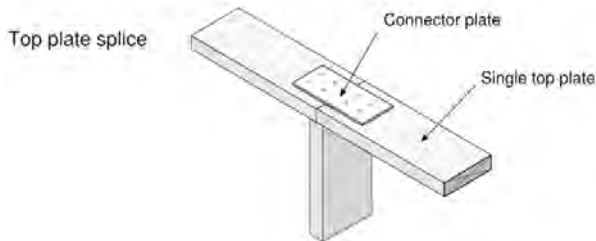
Top Plate Splice over Stud

- Top plate joint aligned over stud
- Connector plate provides structural continuity to top plate

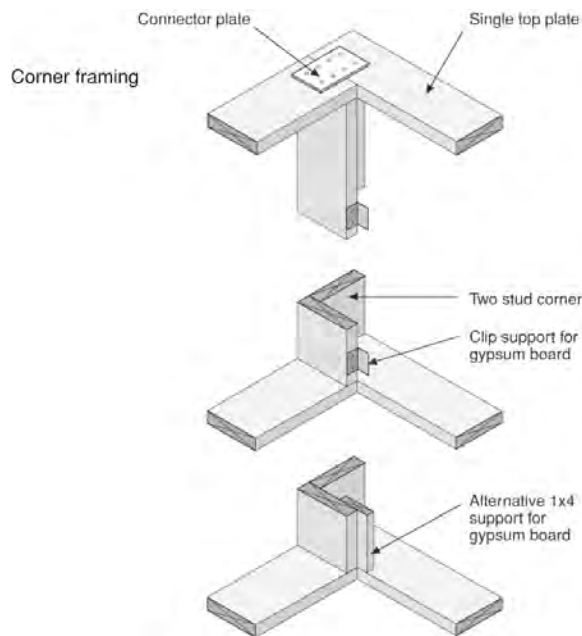
Corner Framing of Exterior Wall

- Thermal bridging by framing is minimized
- Framing cavity space available to insulation is maximized
- Drywall attachment is to one wall only to reduce cracking resulting from differential wood shrinkage. Alternately, use floating corner for the exterior wall.

Similar to exterior corners, adding additional stud framing for drywall support where partition walls intersect exterior walls creates unnecessary material use and unnecessary thermal bridges. The diagram to the right shows how dry wall support at this intersection can be provided by drywall clips or a 1x6 (alternately, a strip of plywood could be used) attached to the back of the partition’s terminal stud. These measures allow insulation of full, or nearly full-, cavity depth to continue past the intersection. Structural connection between the partition wall and the exterior wall can be achieved by a connector plate at the top of the wall and nailing into the floor sheathing at the bottom of the wall.

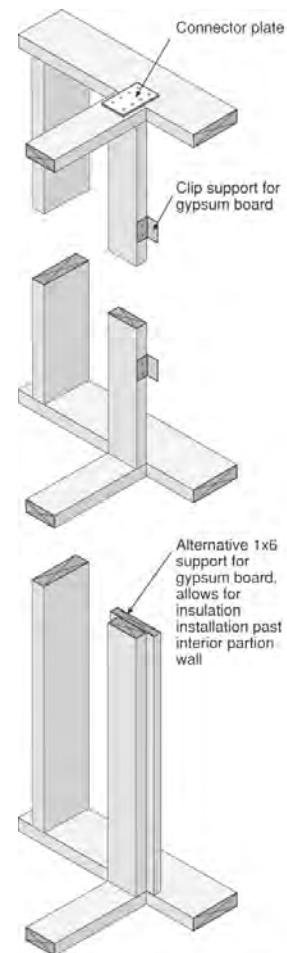
Partition Wall to Exterior Wall Intersection

- Thermal bridging by framing at intersection is avoided
- Insulation continues behind intersection
- Drywall attachment is to partition wall only to reduce cracking resulting from differential wood shrinkage. Alternately, use floating corner for one wall.
