Genesee County Land Bank Authority

Neighborhood Stabilization Program 2 (NSP2)

Invitation for Bids – Exterior General Contractor

924 Eddy St., Flint, MI 48503

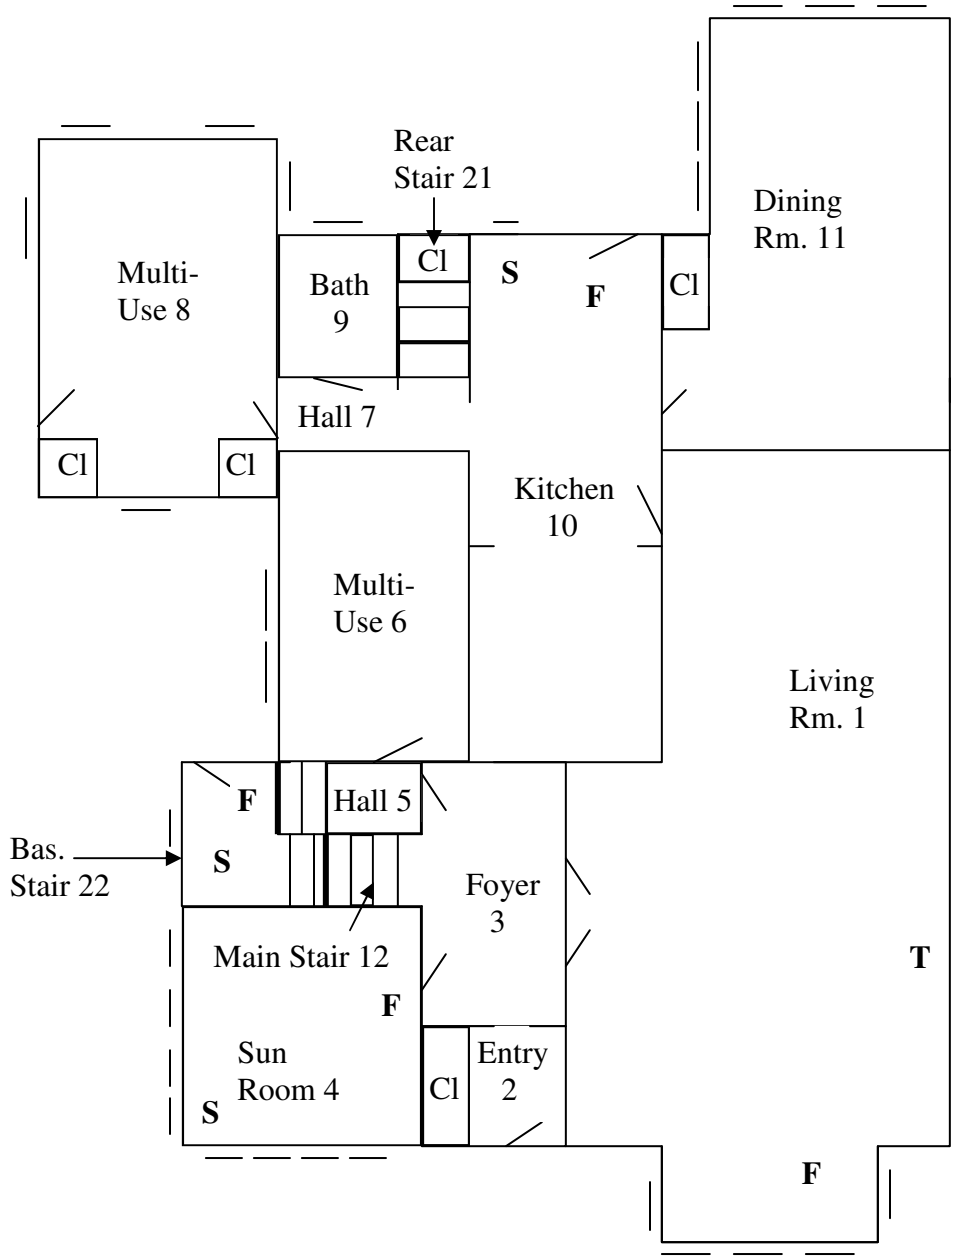
- F = Floor Dust Wipe Sample
- S = Windowsill Dust Wipe Sample
- T = Window Trough Dust Wipe Sample
- W = Wood windows
- V = Vinyl windows
- A = Aluminum windows
- M = Metal windows
- GB = Glass block windows

For identifying the rooms and other areas of the interior of the house, a numbering system is used. Most rooms, with the exception of the kitchen and bath could be used for different purposes. When numbers are used, deciphering which room is called what will not be required. See dwelling map and labeling to determine the locations of the tests and hazards.

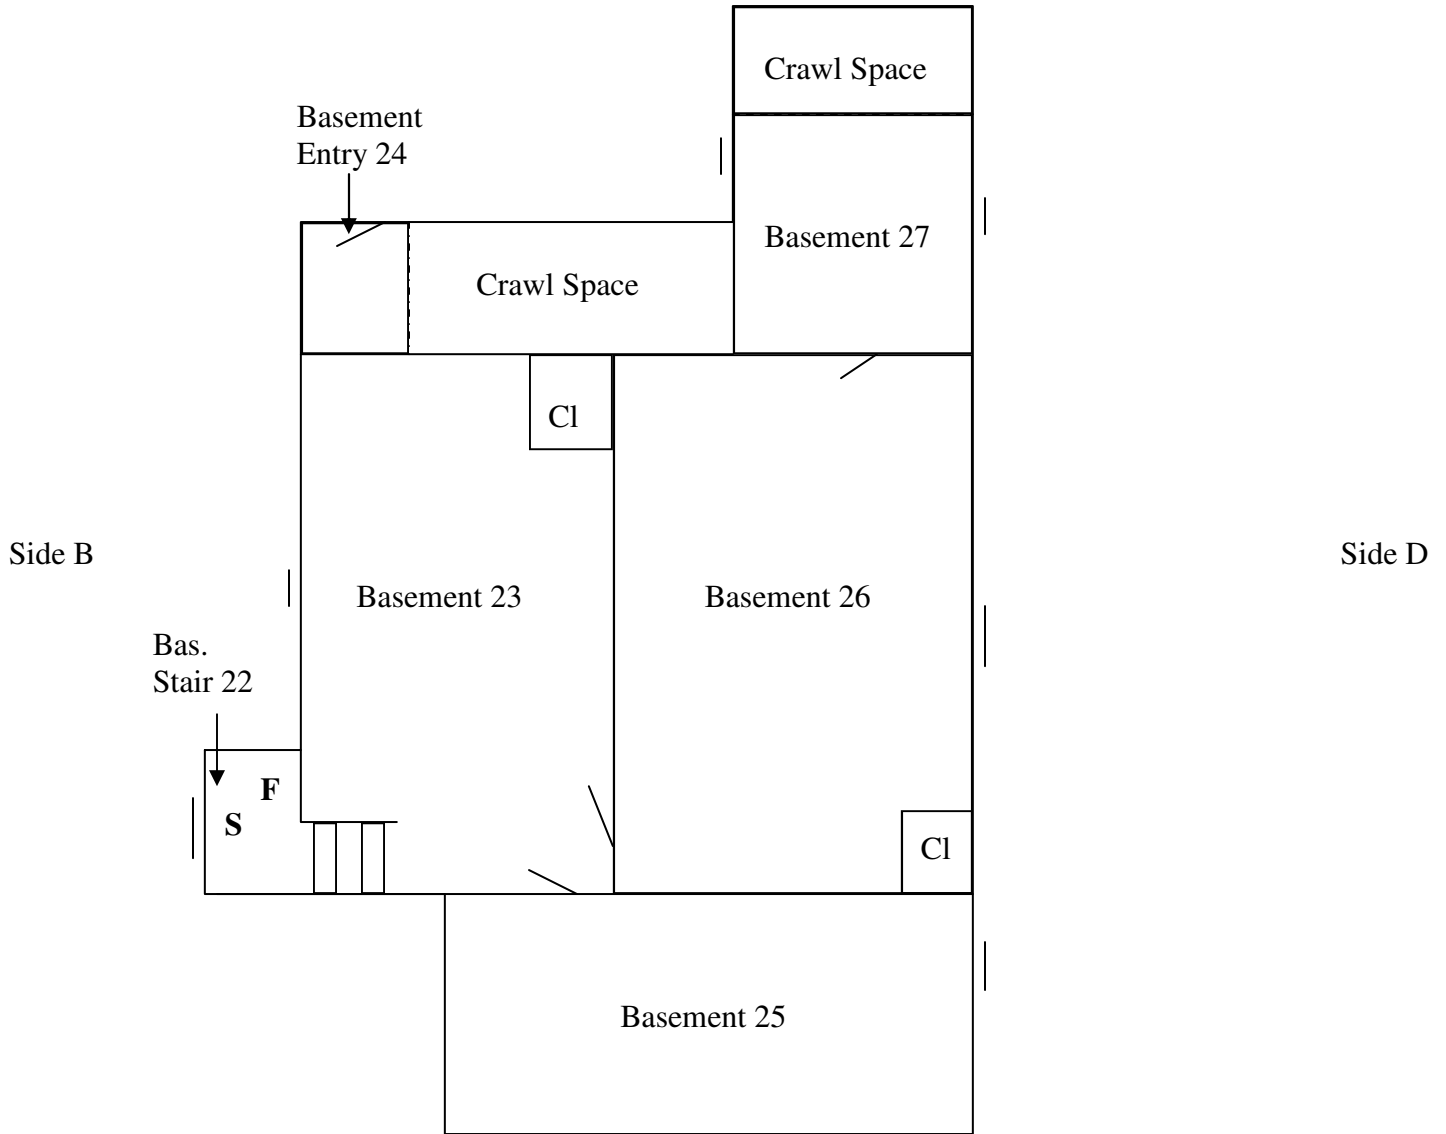
Basement Level

- F = Floor Dust Wipe Sample
- S = Windowsill Dust Wipe Sample
- T = Window Trough Dust Wipe Sample
- W = Wood windows
- V = Vinyl windows
- A = Aluminum windows
- M = Metal windows
- GB = Glass block windows

Please Note: This is a rough floor plan only. All items, (doorways, Windows, etc.) may not be included in this illustration. Also, room and component sizes are not drawn to scale.

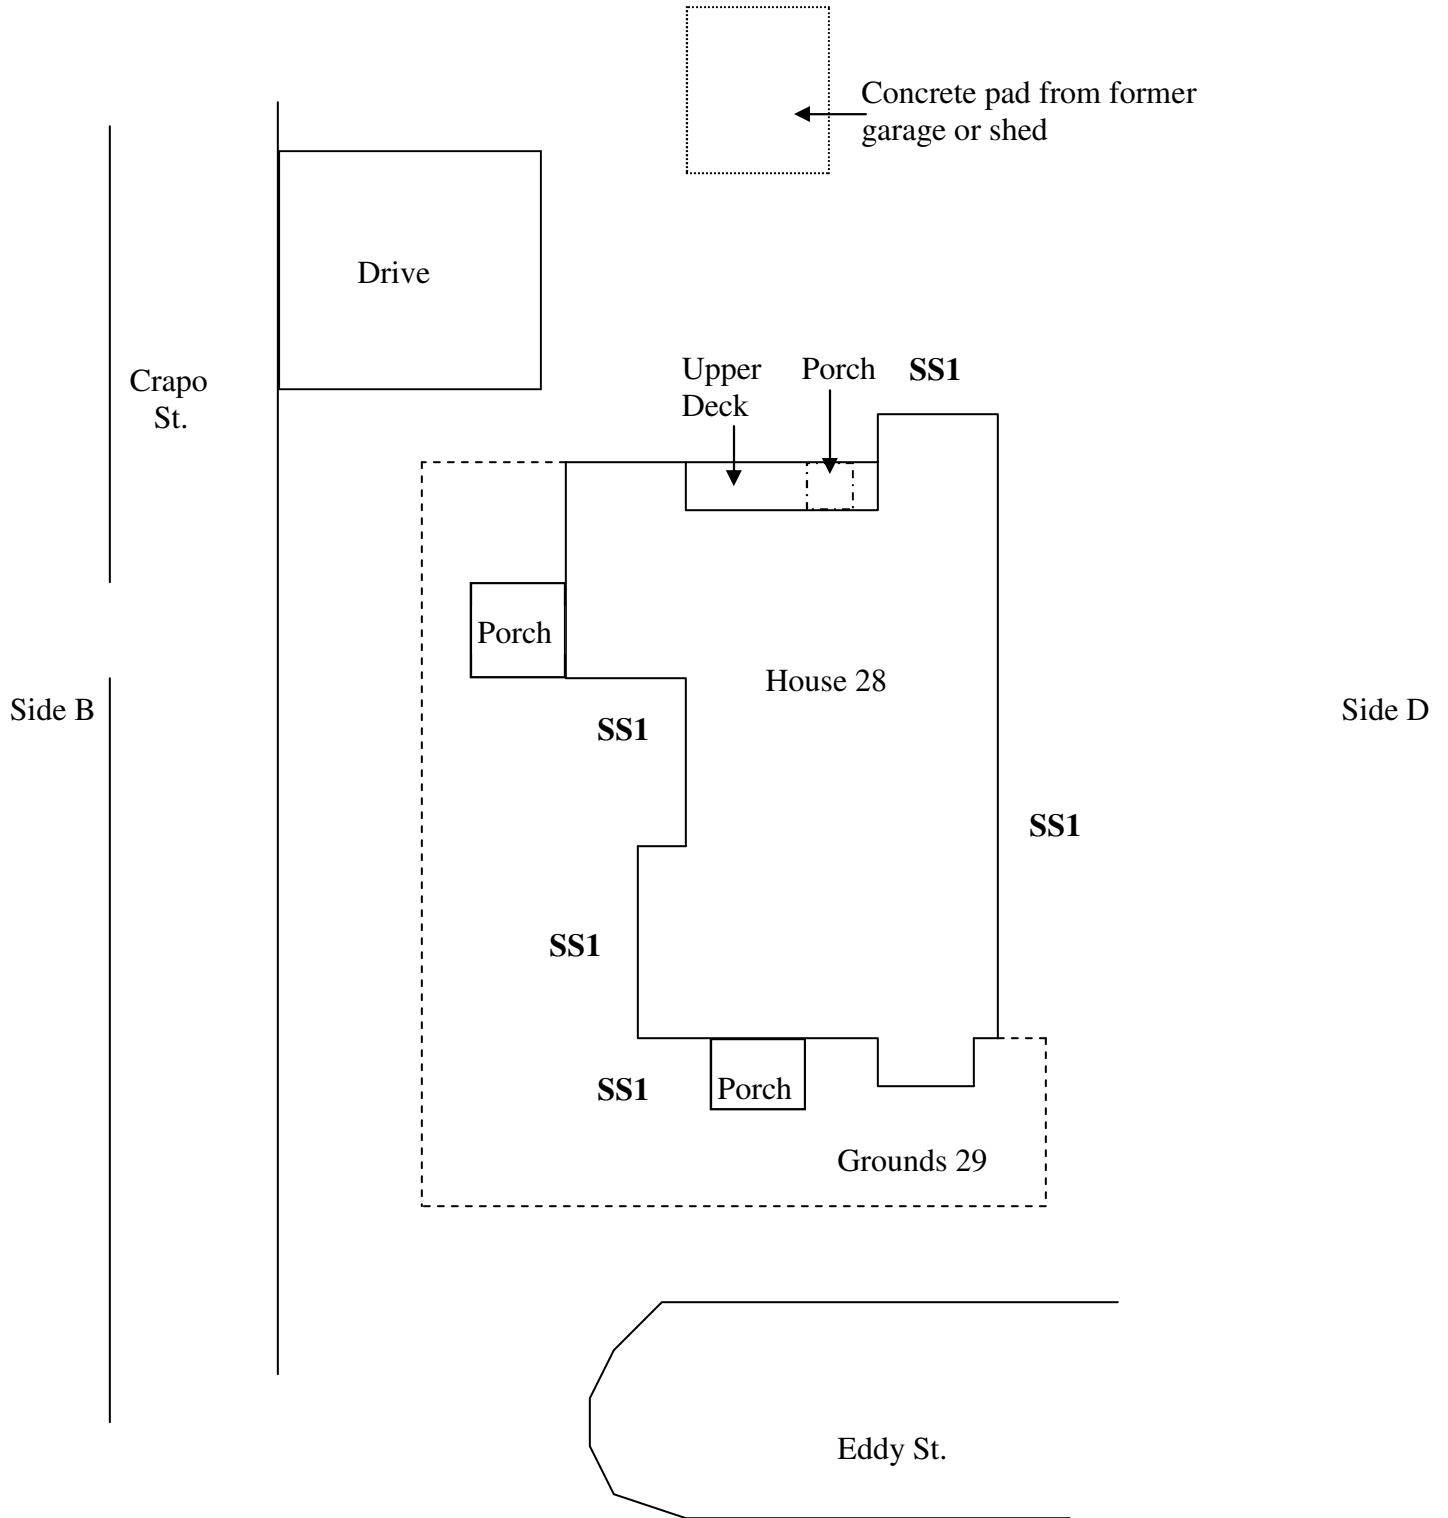
Side C
Site Layout

SS = Soil Sample

Please Note: This is a rough site plan only. All items may not be included in this illustration. Not drawn to scale.

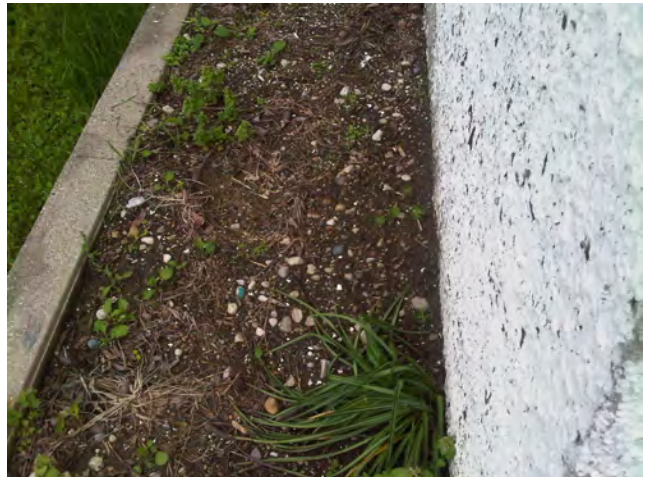
House Perimeter—Paint Chips

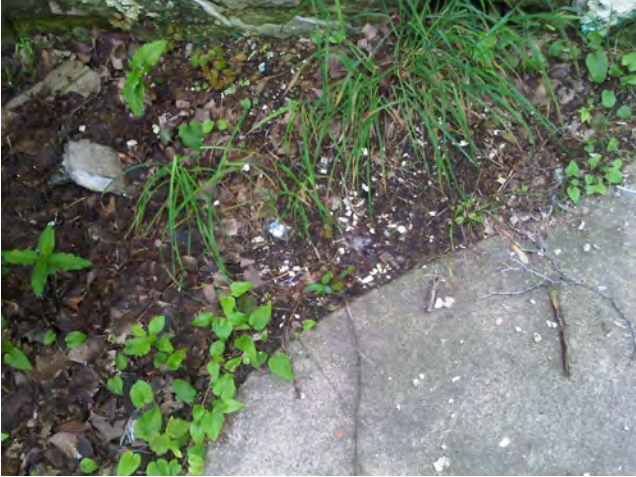
House Perimeter—Paint Chips
