Neighborhood Stabilization Program 2 (NSP2)

Invitation for Bids – General Contractor

1602 N. Grand Traverse St., Flint, MI 48503

Genesee County Rehabilitation Environmental Inspection Summary

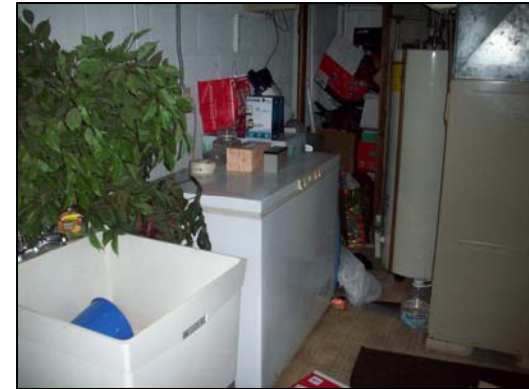
Freezer
Basement Laundry Room

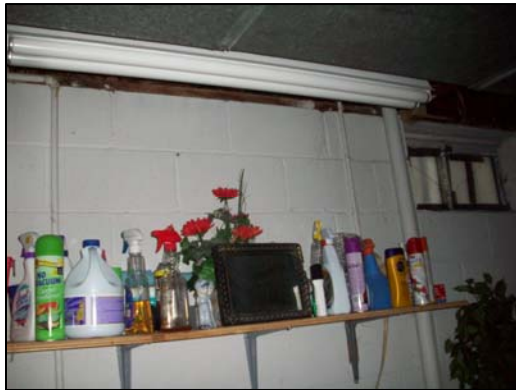
Household Cleaners and Fluorescent Light Bulbs/Ballast
Basement Laundry Room

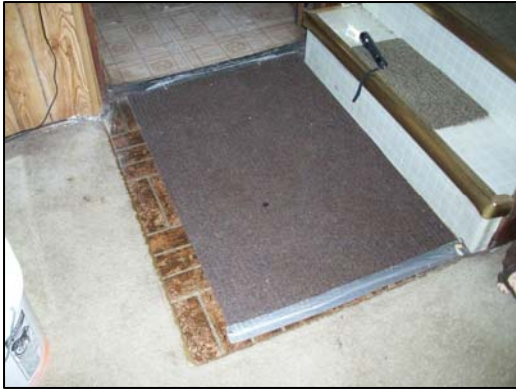
Floor Tile beneath Brown Linoleum – Bottom of
Basement Stairs
NON FRIABLE

The 2-inch tape duct wrap insulation and tape located in the basement laundry room and the floor tile beneath the brown linoleum located at the bottom of the basement stairs should be properly removed and disposed by a licensed asbestos abatement contractor as part of the renovation project. No duct wrap was observed in other areas of the house however it should be noted that since destructive sampling was not completed during this inspection additional duct wrap may be present on duct work above the basement ceiling.

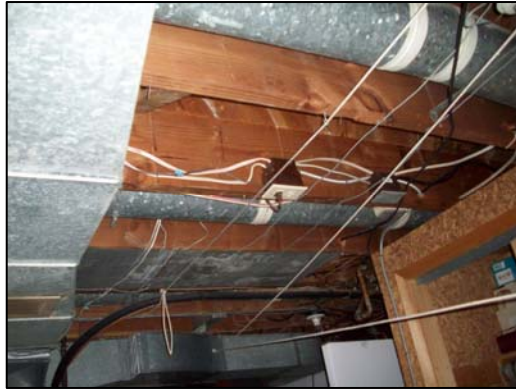
Example of Duct Wrap 2" Tape – Basement
FRIABLE

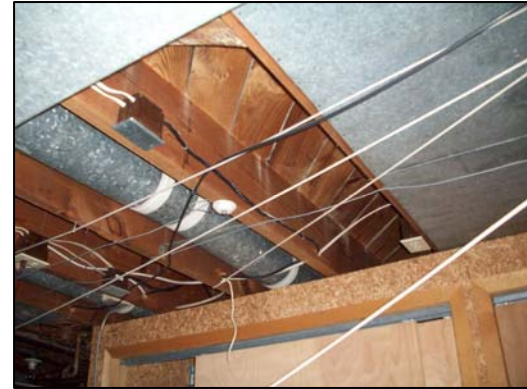
Note: duct wrap was not observed in other areas of the house however it should be noted that since destructive sampling was not completed during this inspection additional duct wrap may be present on duct work above the basement ceiling.

Example of Duct Wrap – Basement
FRIABLE
